Drainage Investigation Report

The House, The Street
The Town

20th May 2010

Drainage Layout Plan

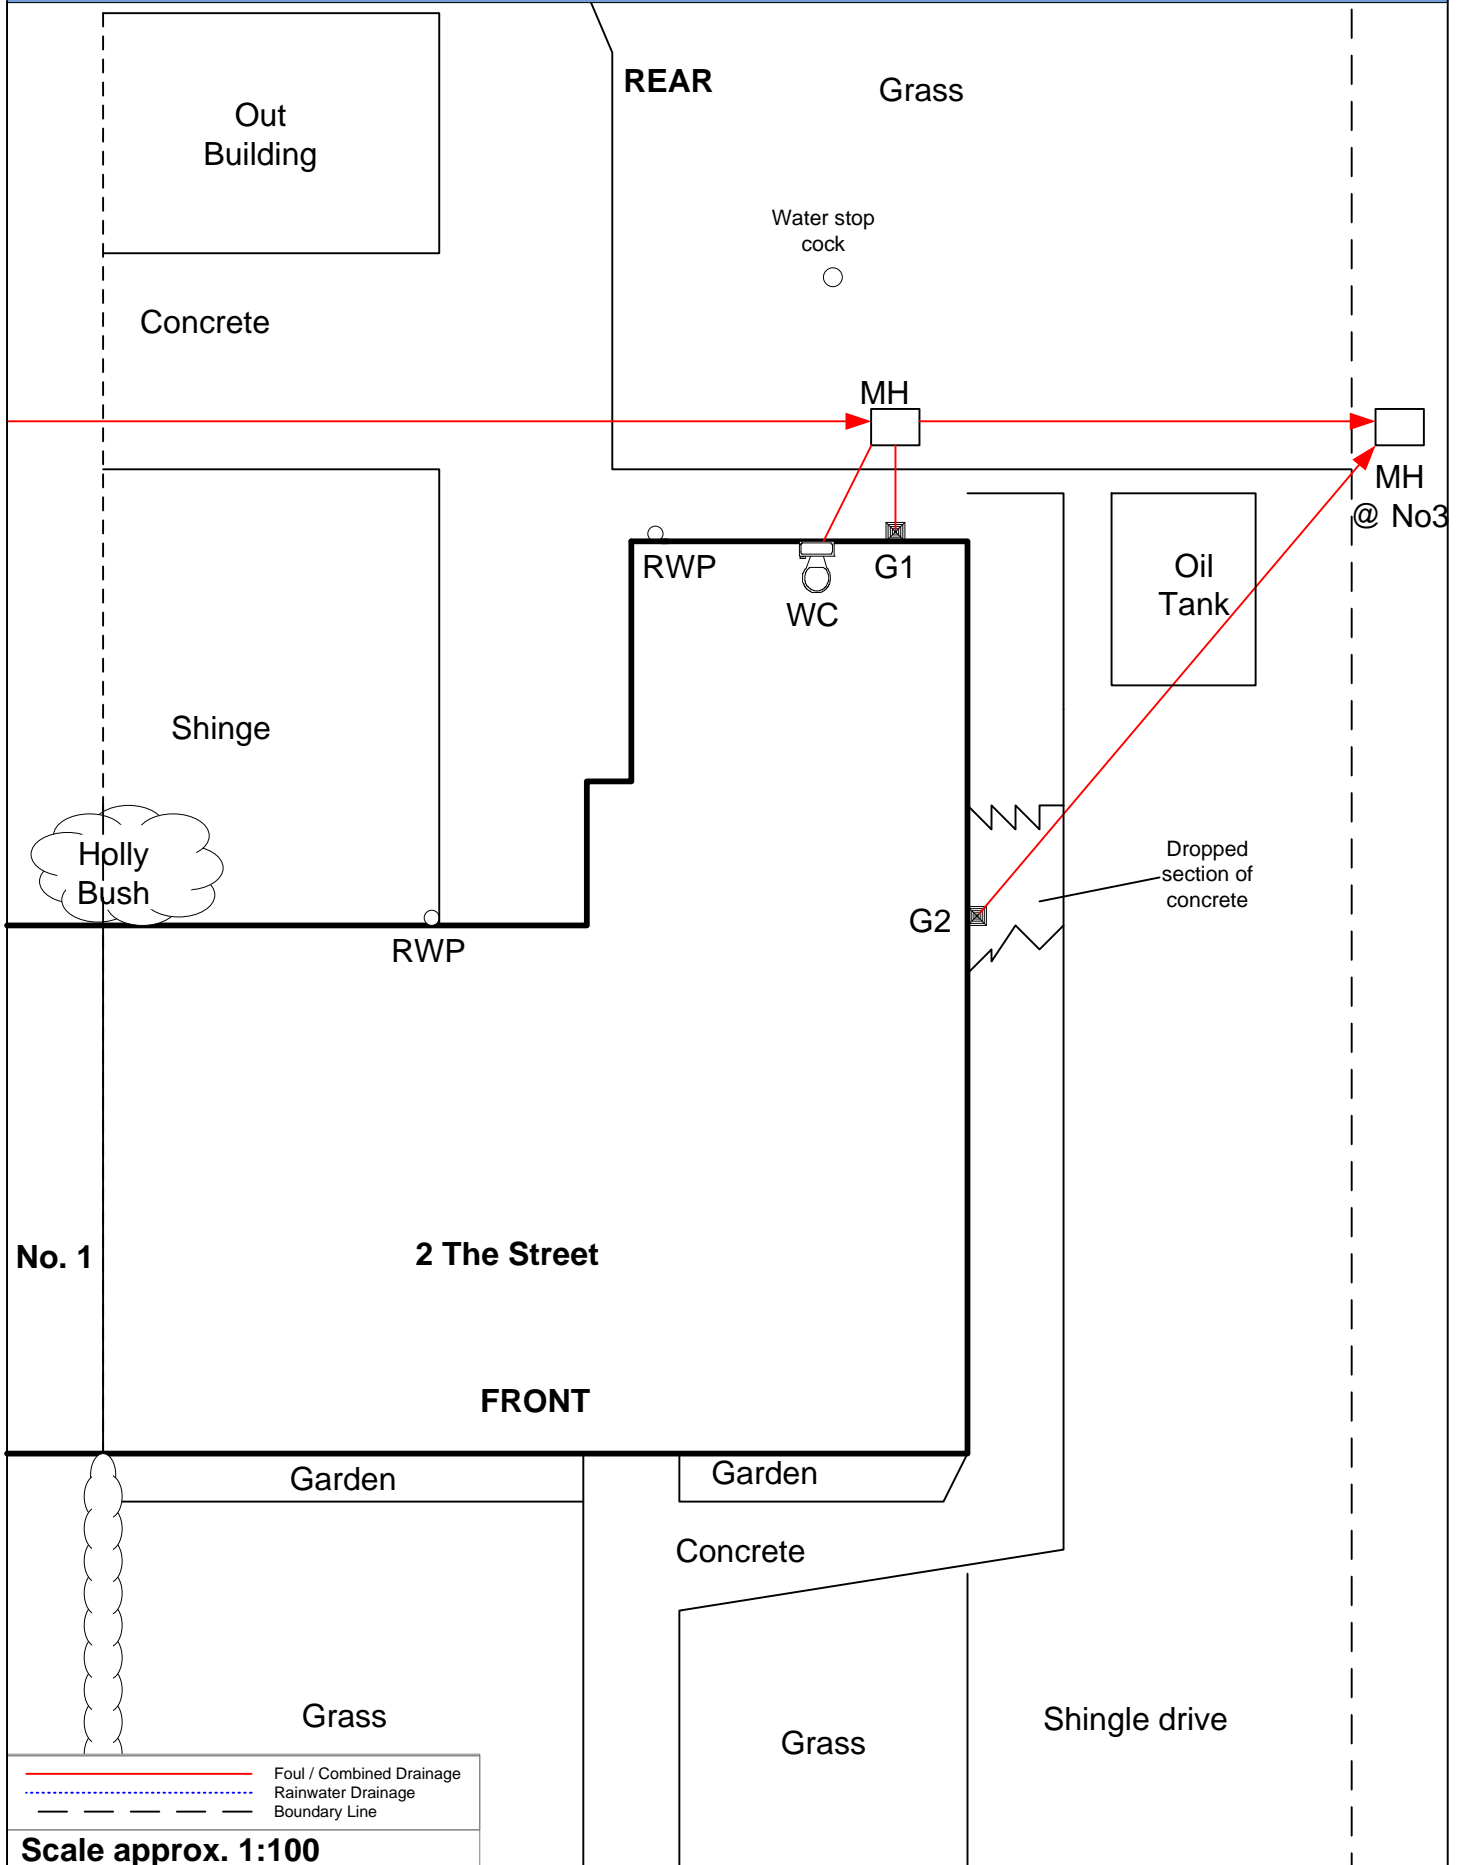
A shared drain runs from left to right across the rear approximately 0.5m from the rear building line. The private branch drains all join via manholes within the boundary or via the manhole at the neighbouring property (No. 1 The Street).

The drainage is constructed from original clay. The three privately owned branch drains were found to be damaged whilst the shared drains were found to be in good condition.

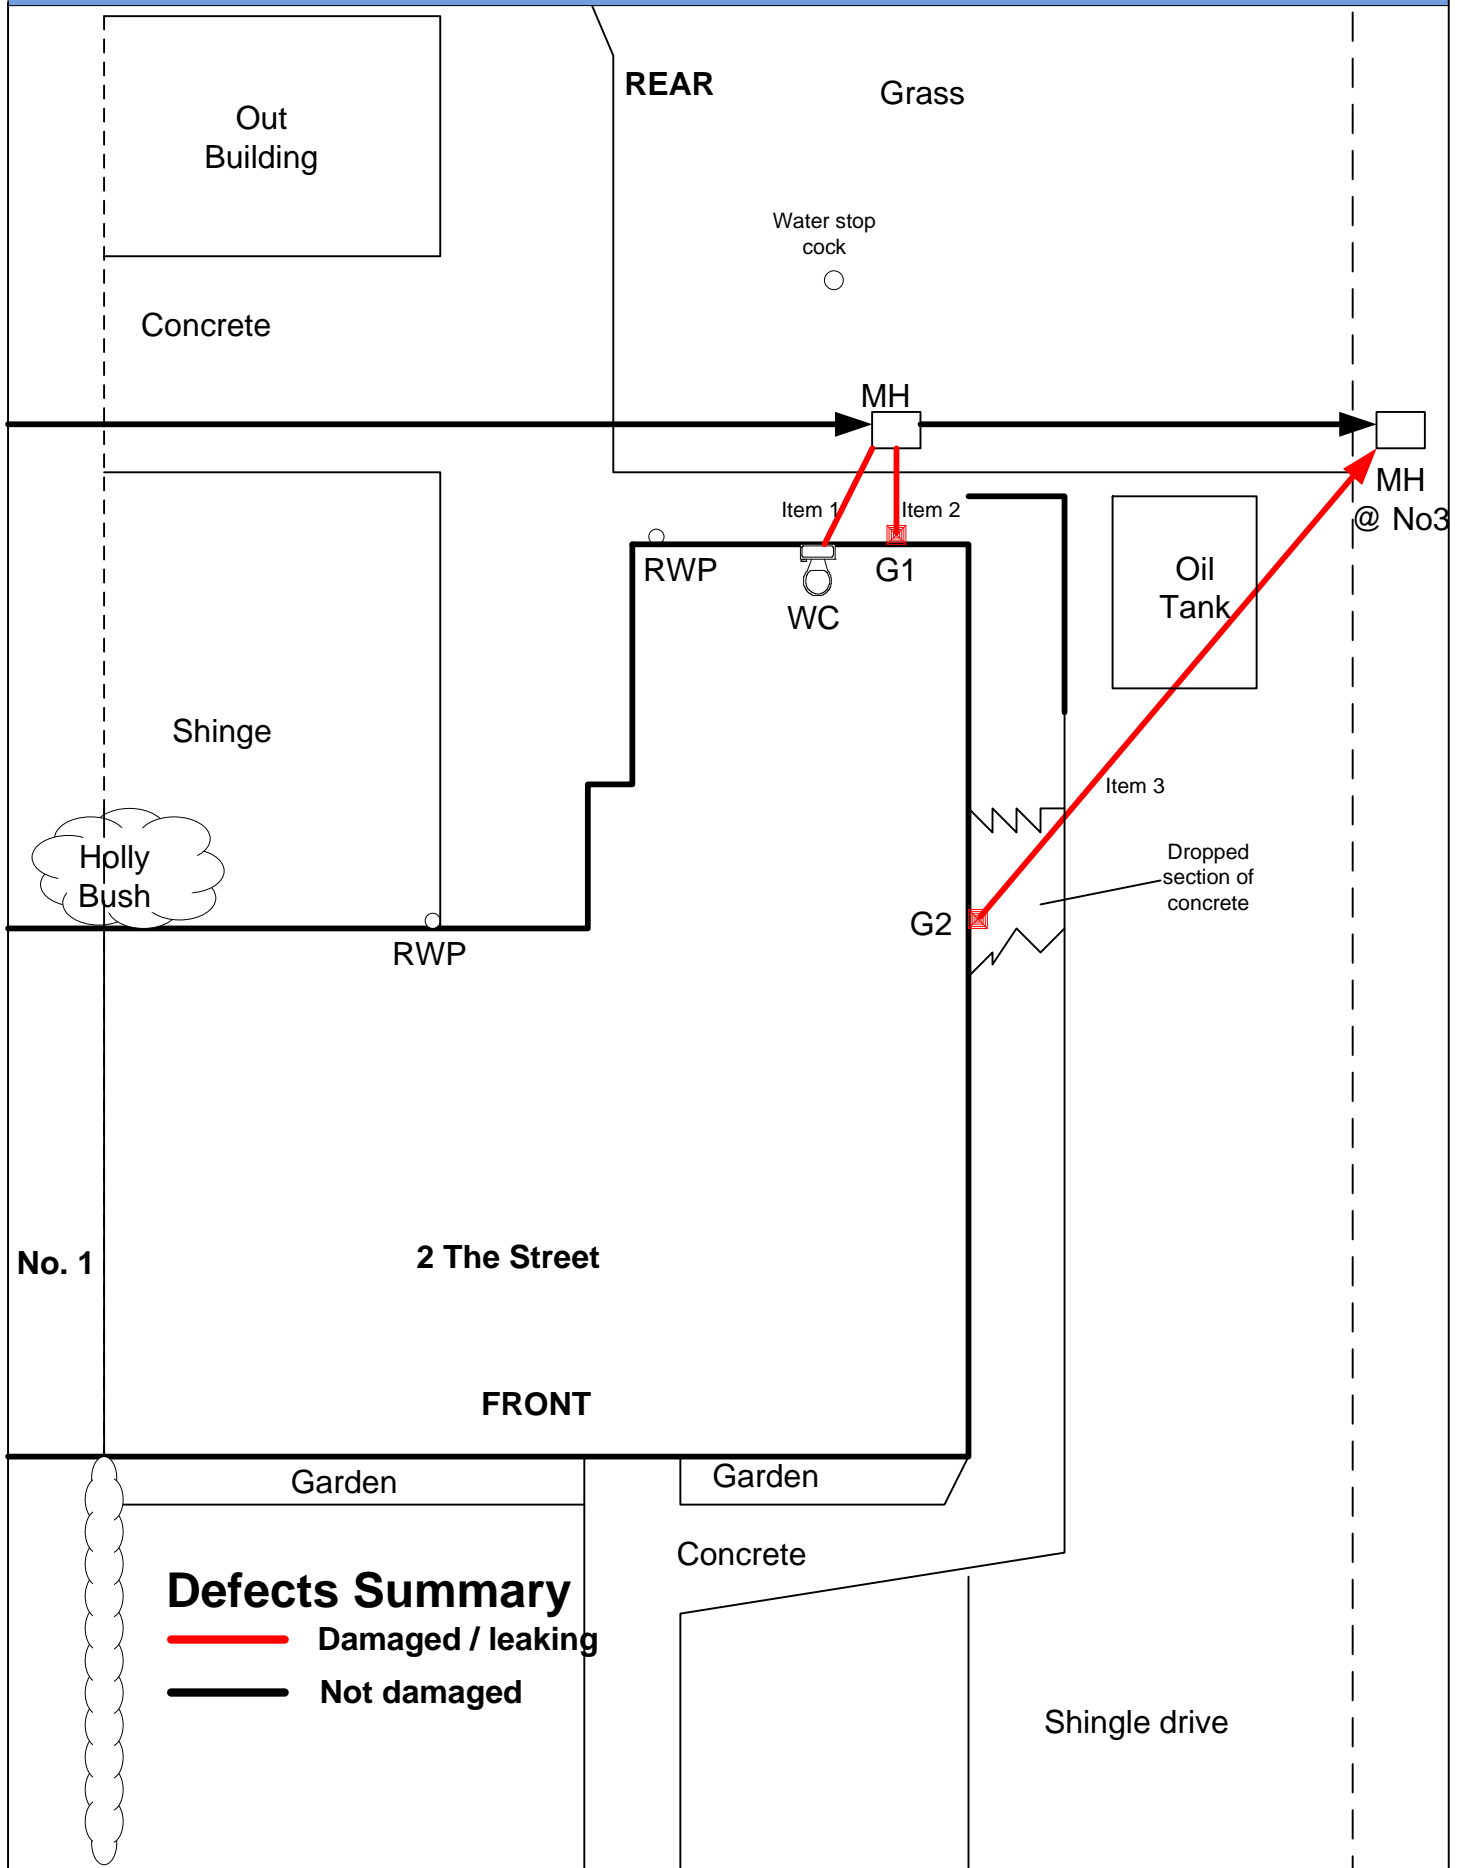
Defects Summary Plan

This drain has a crack at 0.9m. The water pressure testing recorded a severe leakage. We would recommend the drain is repaired and this could be achieved without excavation through the insertion of a structural liner.

The CCTV survey highlights a crack and what appears to be fibrous to roots. The water pressure testing recorded a severe leakage and we would recommend the drain is replaced including the gully hopper which is badly damaged. The benching around the gully is also damaged and could be allowing water to escape next to the building line.

The concrete path around this gully has dropped. The below ground drain is also damaged with a number of cracks. Unusually, only a slight leak was recorded during testing.

The benching around the gully is defective and could allow water to escape in to the ground next to the building line. As the drain leaks, we would suggest replacing the gully and installing a structural liner as far as the manhole next door. The concrete around the gully would be reinstated as part of the works and if required the section of dropped concrete path could be cut out and replaced.
