Eastern Drainage

Drainage Investigation Report

Another House, Another Street
The Village

20th May 2010

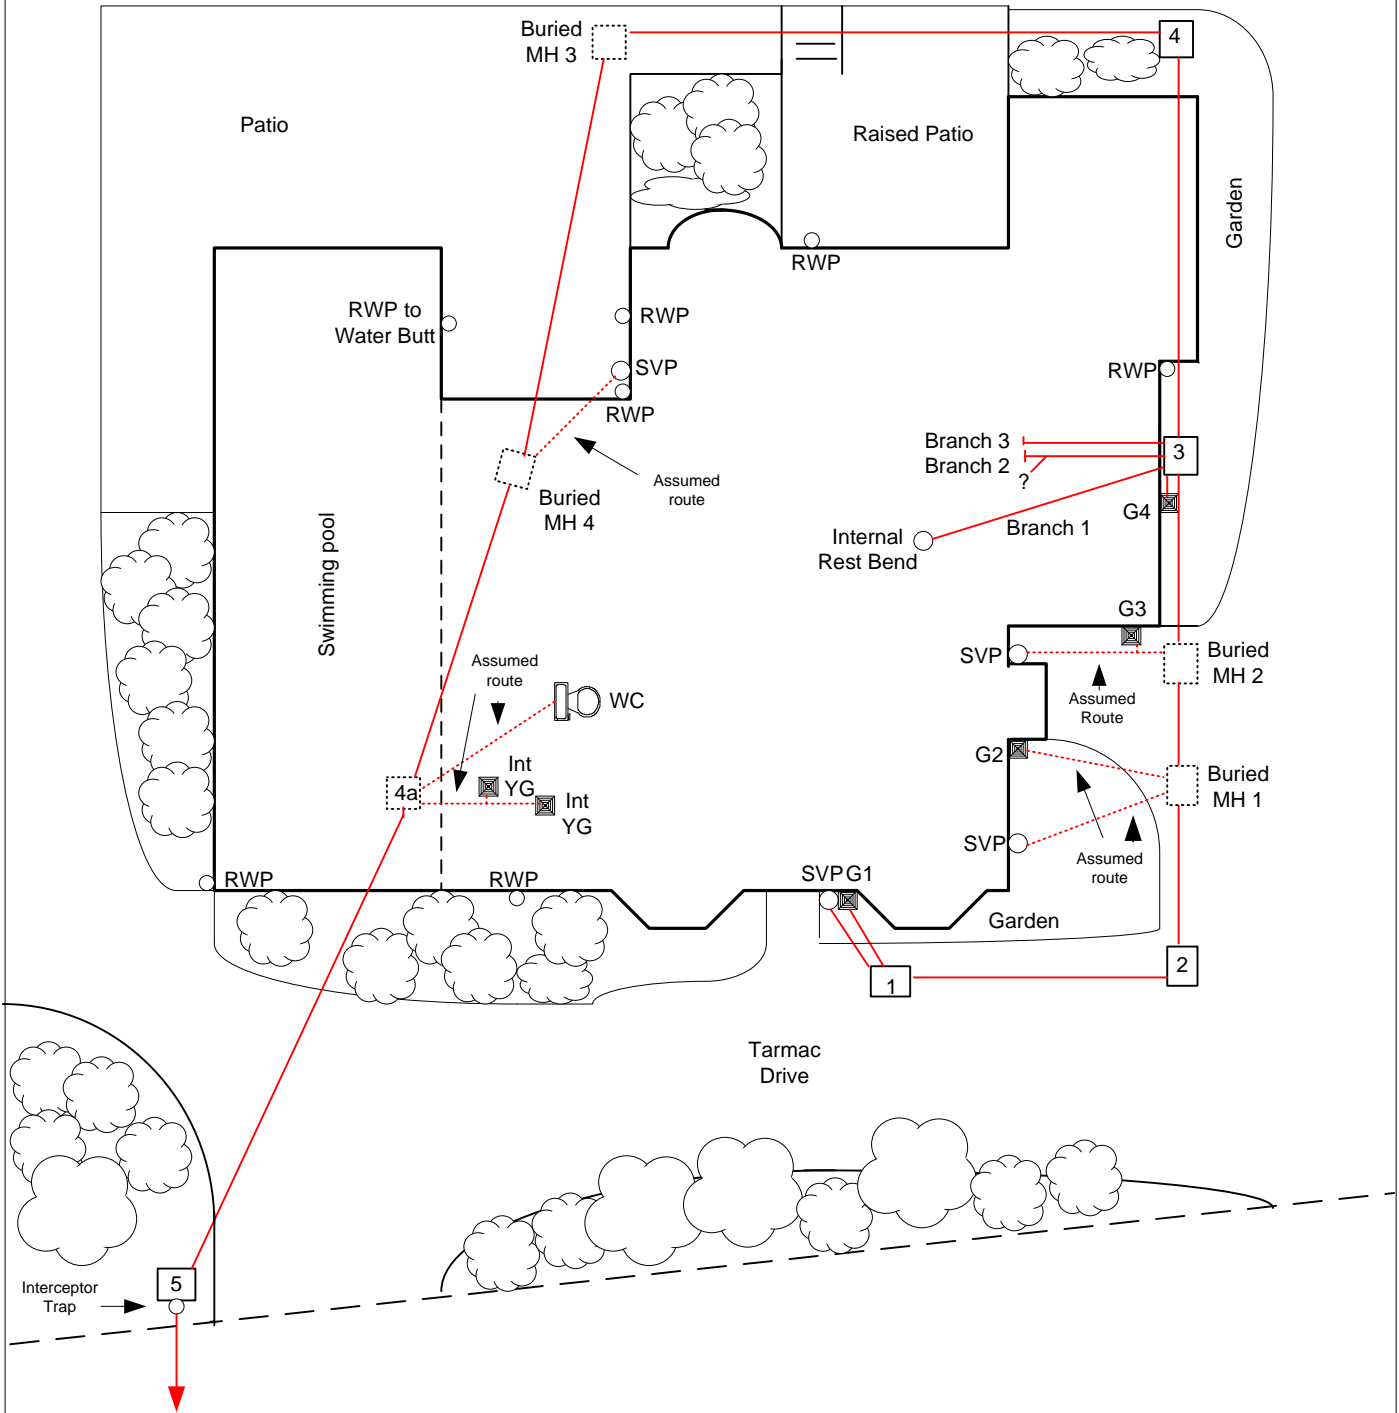
Drainage Layout Plan

The property is served by mains foul drainage constructed from clay pipework with the exception of gully 4 which is uPVC.

The drains run from the front right corner, along the right hand side, across the rear, beneath the extension and pool house out to manhole 5 and the main sewer in the road at the front.

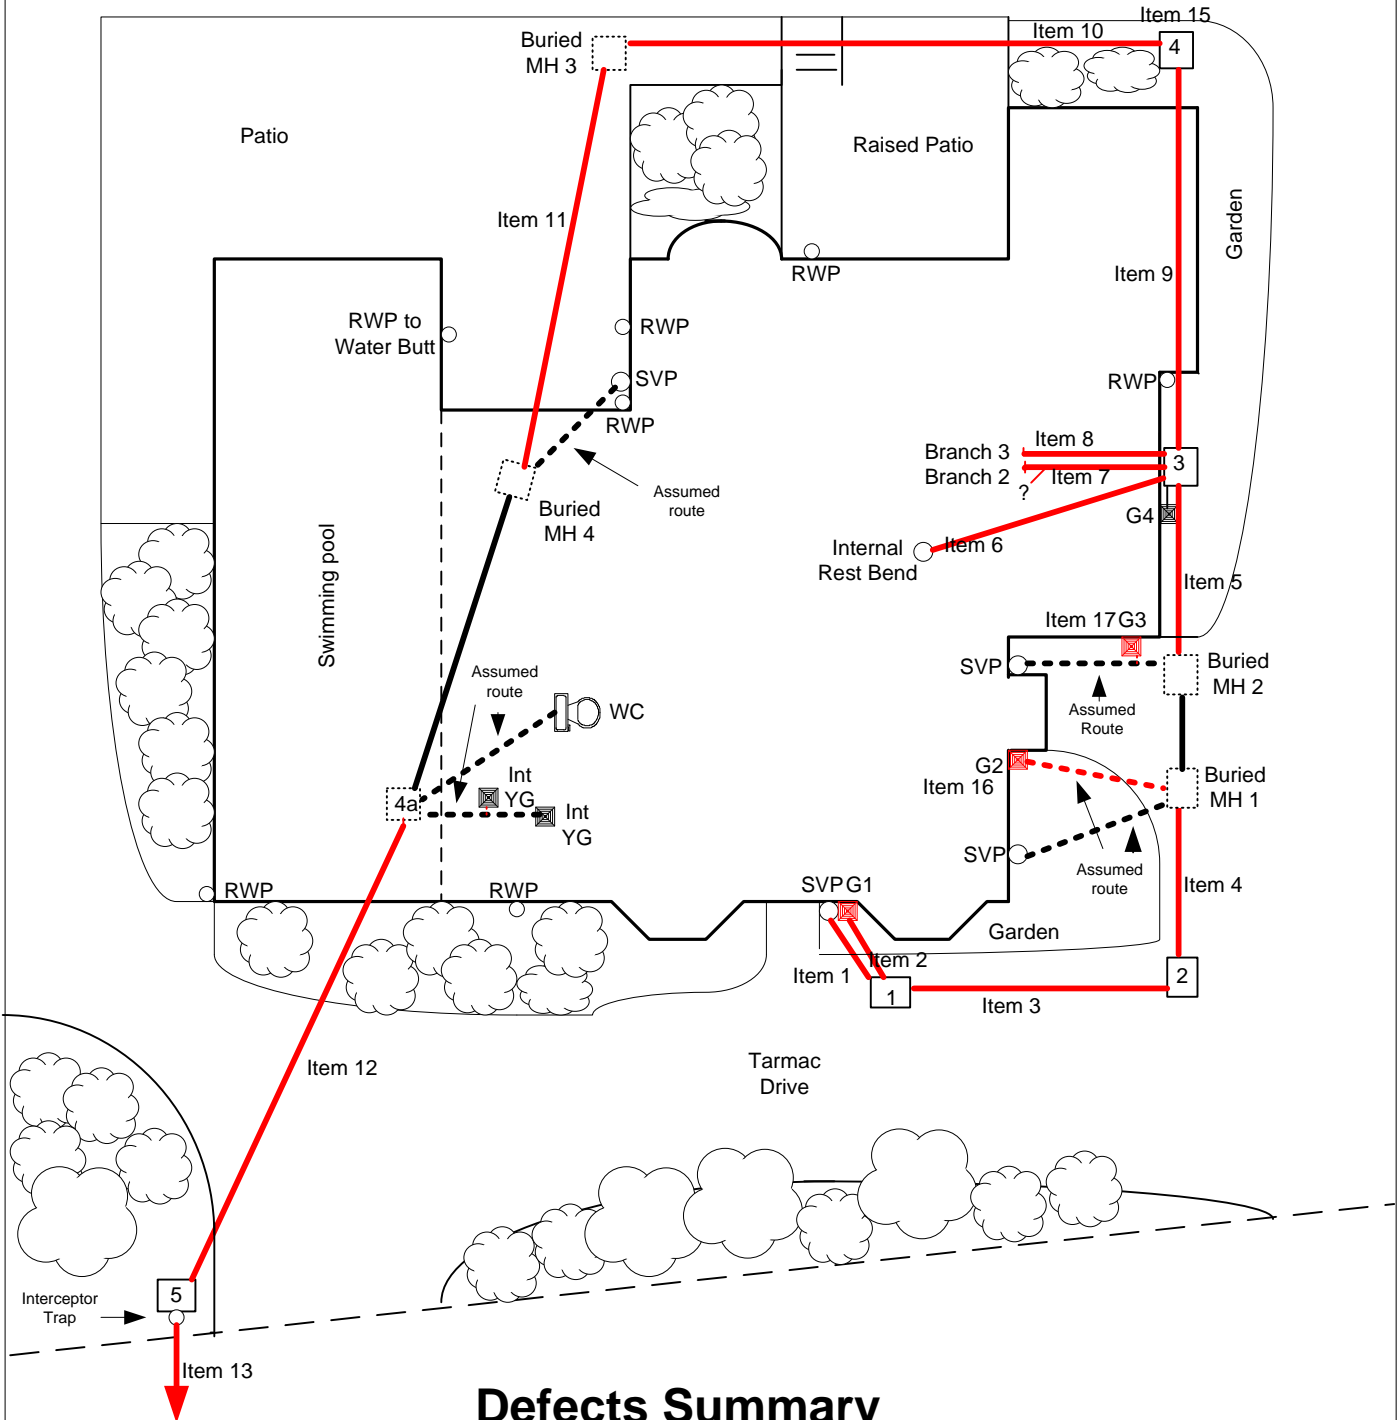
Defects Summary Plan

Defects Summary

- Damaged (cracks/roots)
- Not damaged
- - - - Not examined
